# SmartNav4 false contact repair

When the unit shows erratic behavior or the device isn't installing properly, you may look for a shortcut between its internal components.

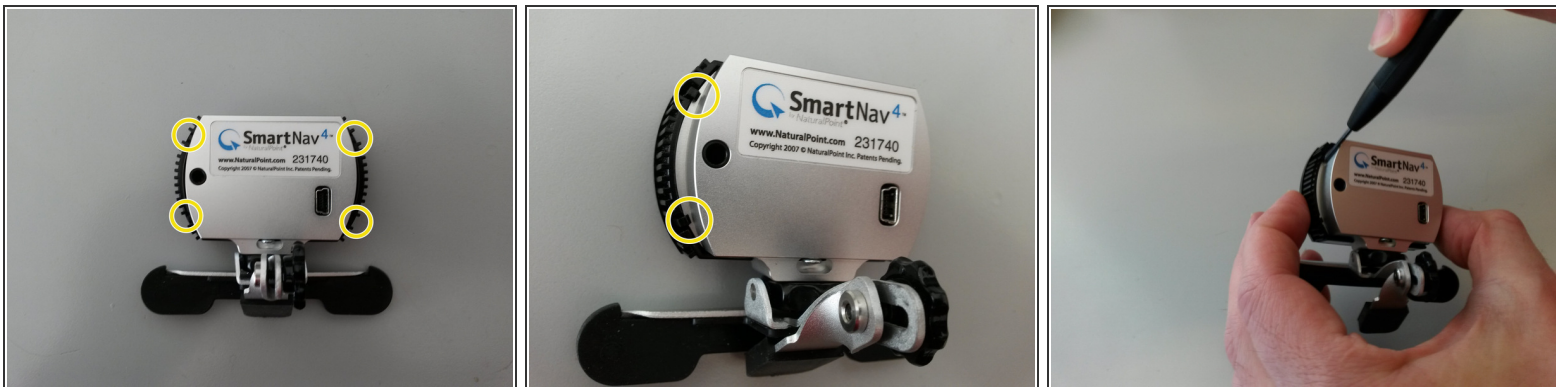
## Step 1 — Device opening

- Gently open the four plastic tongues with a small slotted screwdriver, you need to keep the black and silver plastic gently pulled apart.

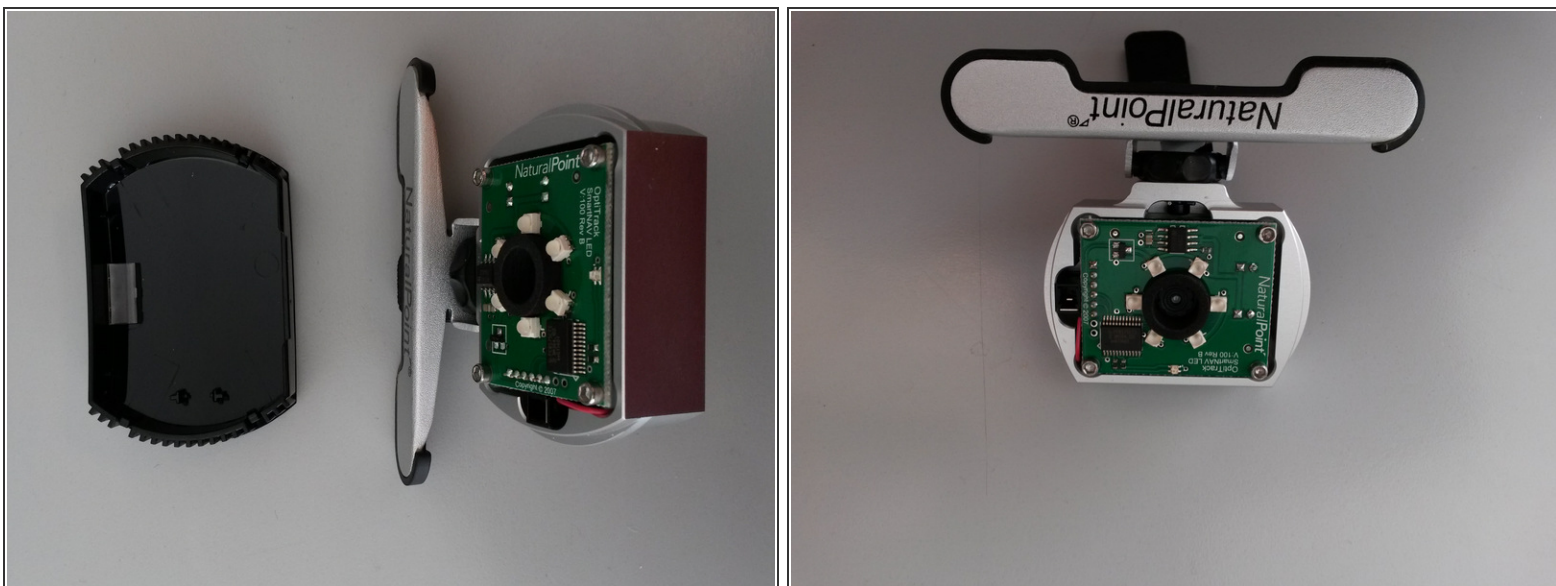
## Step 2

- Once separated, there are four hex screw to be removed.
- I guess the size is 5/64" but I've used a 2 mm bit.

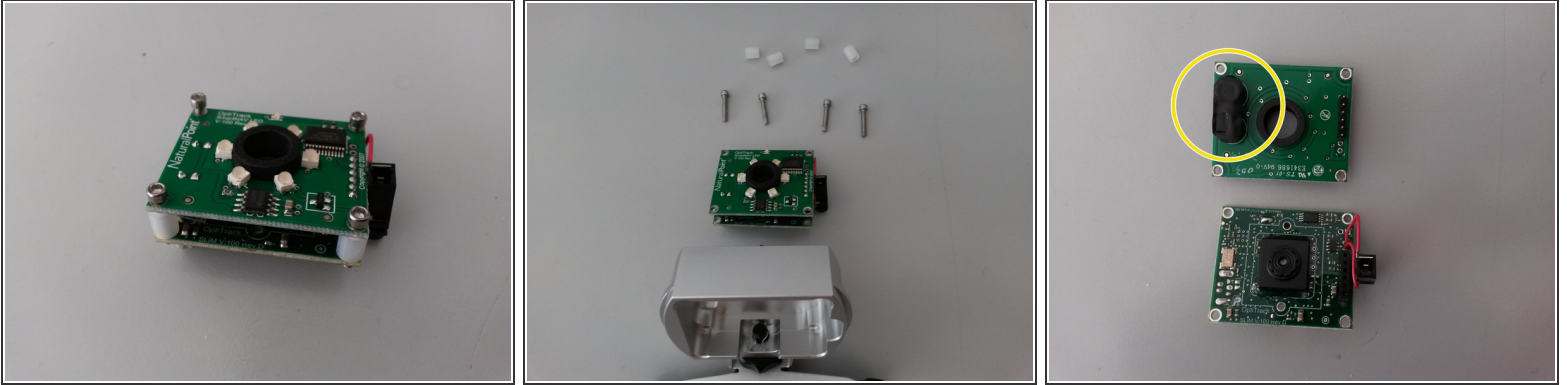
### Step 3

- Extract and separate the components.
- The problem it is located in the black film between the boards. Which is clearly pinched through.
